**North America's
Full Service
Jabiru Center**

SERVICE BULLETIN	
Service Bulletin #	JSA-003-1
Superseded Bulletin #	JSA-003
Issue Date	08/27/2009
Effective Date	08/27/2009
Limitations for Completion	Before the Next Flight
Make & Model Affected	J250-SP Serial # All
	J230-SP Serial # All
	J170-SP Serial # All
Page 1 of 5

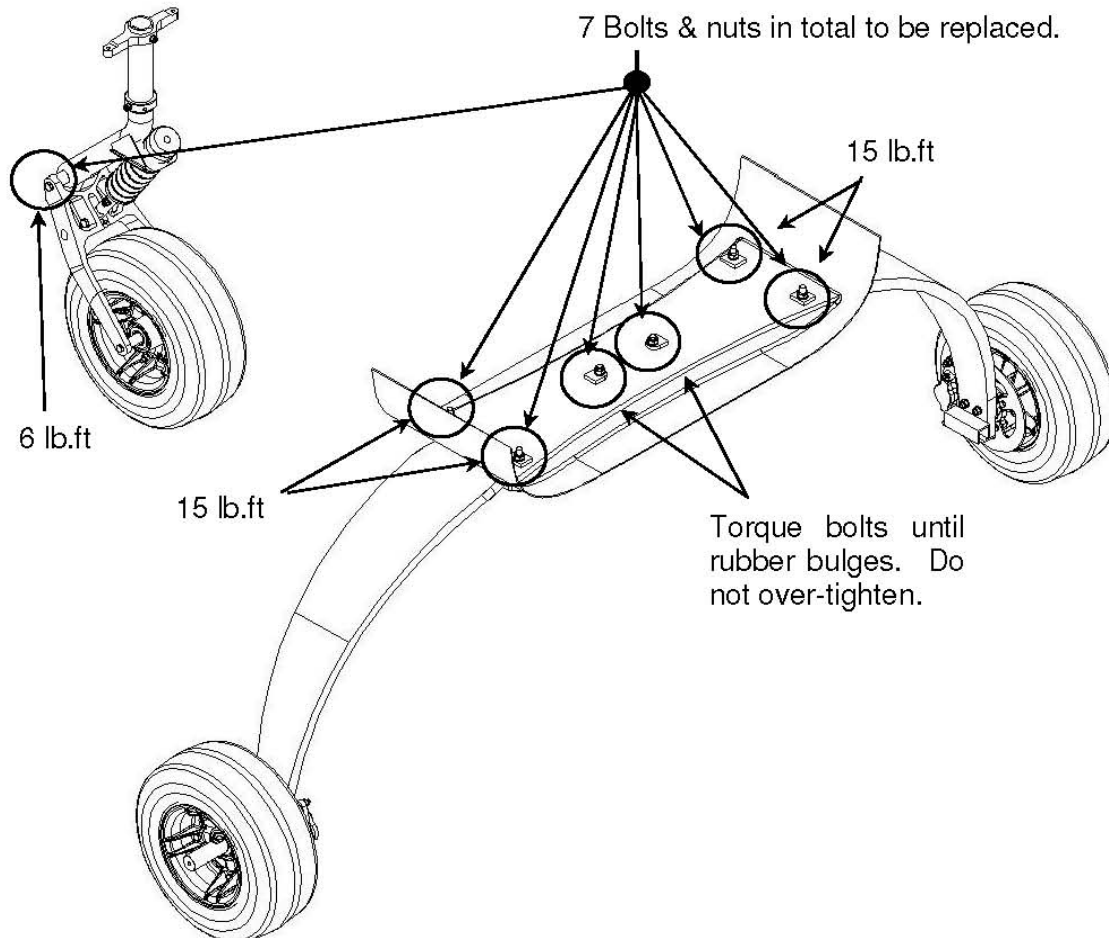
Figure 1 – Undercarriage

- Several bolts used in the undercarriage of Jabiru Aircraft are subject to relatively high loads and vibrations.
- To reduce the frequency of undercarriage bolt failures a 500-hour life has been applied to several critical bolts.

- A procedure for removing the undercarriage legs is given in the Service Manuals of all Jabiru Aircraft and is to be used for this task.
- Figure 1 shows a general schematic of a tricycle undercarriage for a Jabiru Aircraft. The bolts which are to be replaced are indicated. While there are detail differences between Jabiru models all have the same general layout and have the same critical 7 bolts which are to be replaced.

- Bolts and nuts used in the positions shown in Figure 1 are to be replaced at the first 100 hour inspection or annual condition inspection after 500 hours Time In Service (TIS).
- Bolts which have already surpassed 500 hours TIS are to be replaced at the aircraft's next 100-hourly or annual inspection.

- The length of the new bolt fitted should match that of the old bolt being removed. Please confirm the correct length of the bolts for your aircraft before ordering bolt kits.
