SERVICE BULLETIN	
Service Bulletin #	JSA-005
Superseded Bulletin #	N/A
Issue Date	10/07/2010
Effective Date	10/07/2010
Limitations for Completion	Contingent Upon Inspection
Make & Model Affected	J250-SP – All through s/n 585
	J230-SP – All through s/n 679
	J170-SP – All through s/n 186
Page 1 of 4

Service Bulletin JSA-005 has been issued to correct a bolt-clearance problem in the brake/wheel pant bracket assembly that will cause abnormal brake wear and loss of brake effectiveness over time.

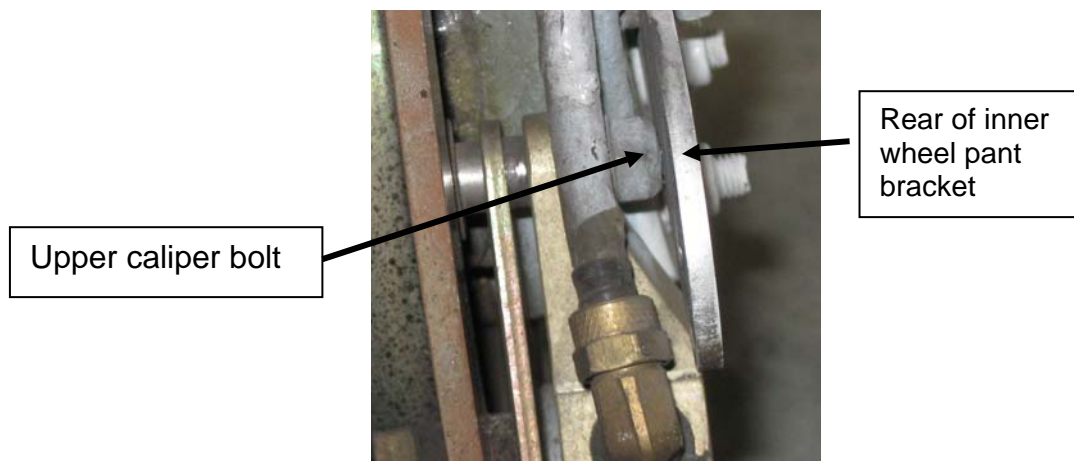
During annual inspection of an aircraft with worn brake pads, the mechanic noticed contact between the upper brake caliper bolt and the inner wheel pant bracket (see Figure 1) when brakes were applied. The interference prevented the outer brake pad from contacting the brake disc, which caused abnormal wear of the inner brake pad and reduction of brake effectiveness. The problem was corrected by drilling a relief hole in the inner wheel pant bracket to allow the bolt to pass through the bracket with no contact.

Figure 1: Rear view of left caliper and bracket. With brake applied, caliper bolt contacts bracket. (Note slight bow in bracket.)

- c. Materials and Parts Required
 - i. 4 x AN365-428 Locking nuts (new)
- d. Remove main wheel pants as per applicable aircraft service manual.
- e. Apply and lock parking brake. Examine the upper caliper bolt clearance to the wheel pant bracket. If the bolt hits the bracket (see Figure 1) or clearance is less than 1/16", the clearance hole must be drilled before the next flight. If the clearance with brake applied is 1/16" or more on both brake assemblies, the relief hole may be drilled at the next 100-hour or annual inspection.

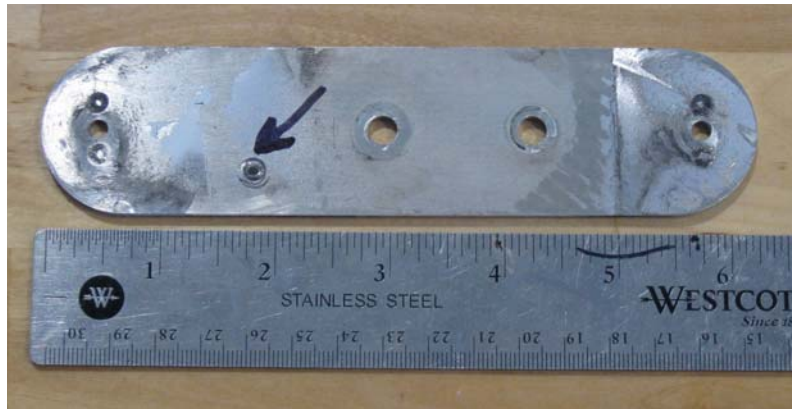
Figure 2: Mark on outside of right-hand inner wheel pant bracket caused by contact with caliper bolt.

- f. If clearance is less than 1/16", remove inner wheel pant bracket. If the bolt has contacted the bracket, there may be a mark which can be used to locate the clearance hole. If no mark is present, drill a pilot hole approx. 1 1/8" from the center of the aft bolt hole and 3/8" up from the bottom edge of the bracket (see Figure 2). Enlarge the hole to at least 9/16" using the Uni-Bit. If the edge of the clearance hole is less than 1/8" from the lower edge of the bracket, it is acceptable to remove the material and create a rounded notch, rather than a hole. Deburr and polish edges of hole/notch.

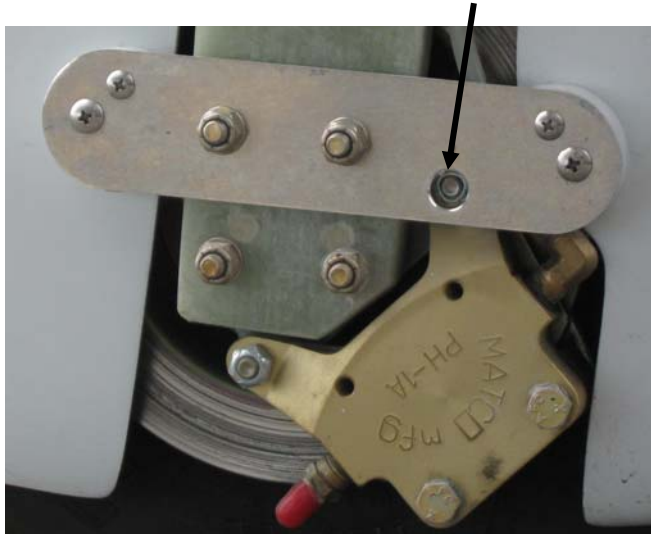
Figure 3: Completed relief hole with wheel and pant reinstalled.

- g. Reinstall inner wheel pant bracket using new AN365-428 nyloc nuts and standard AN torque specifications. Apply full brake and inspect to ensure there is no further contact between bolt and bracket.
