**North America's
Full Service
Jabiru Center**

Service Bulletin #	JSL 008-1
Superseded Bulletin #	NONE
Issue Date	8/8/2017
Effective Date	8/8/2017
Limitations for Completion	NEXT 50 HOUR or Annual/100 Hour Inspection whichever is first
Make & Model Affected	ALL JABIRU LIGHT SPORT AIRCRAFT
	S/No. Range: ALL
Page # 1 of 4 pages	
Service Bulletin

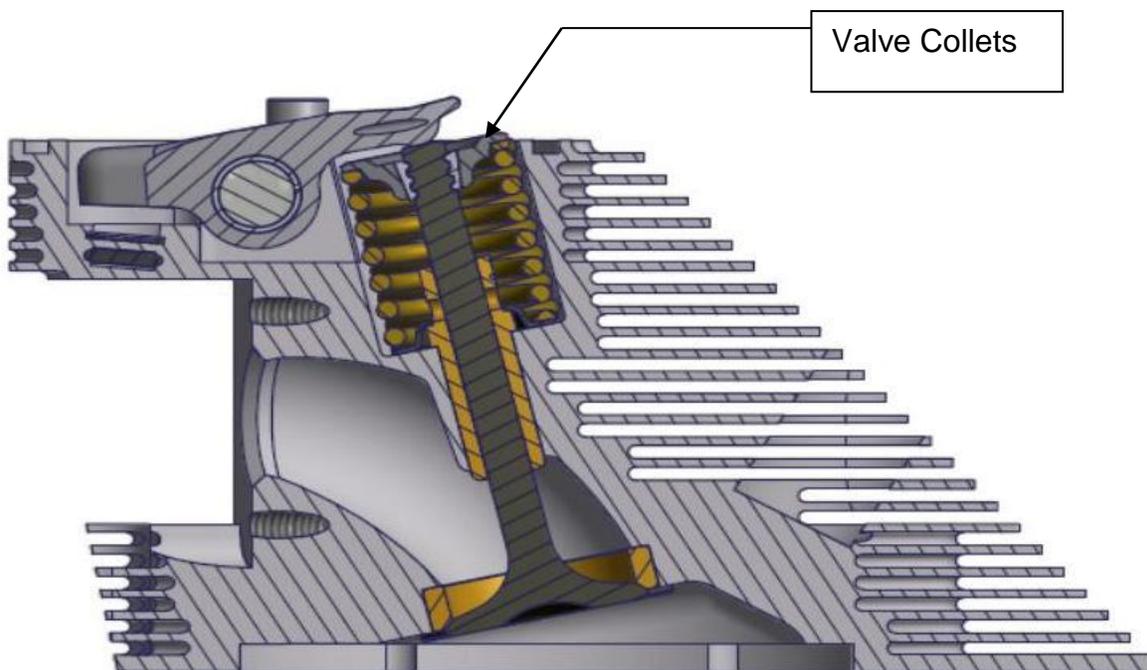
Figure 1 – Valve & Spring Cross Section

- Jabiru Engines use a conventional arrangement of washers and collets to retain the valve spring assemblies (Figure 1).
- By design the valves are free to rotate within the valve collets. The valve actuation mechanism applies a small rotational force to the valve, rotating it to maintain valve sealing.

- Incidents have been reported to Jabiru Aircraft where a valve jammed in the collet, causing the top spring washer to rotate with the valve and wear against the valve spring, eventually causing a failure of the washer and engine stoppage.

- It is likely that dirt or corrosion contamination caused the valve to jam in its collets.
- This document alerts owners and maintainers to the potential issue. The inspections detailed below are mandatory for all Jabiru Aircraft operating in the Light Sport categories and documentation will be included in the next revision of the aircraft Service Manual and LSA annual and 50 hour inspection checklists.
