**North America's
Full Service
Jabiru Center**

SERVICE BULLETIN	
Service Bulletin #	JSA-004-1
Superseded Bulletin #	JSA-004
Issue Date	11/25/2009
Effective Date	11/25/2009
Limitations for Completion	At Next 50, 100, or Annual Insp.
Make & Model Affected	J250-SP Serial # 248 thru #577
	J230-SP Serial # 501 thru #660
	J170-SP Serial # 75 thru # 185
Page 1 of 4

- A few Jabiru J230-SP and J250-SP aircraft have had wheel pant bracket failures.
- To reduce the frequency of failure a stronger bracket has been designed.

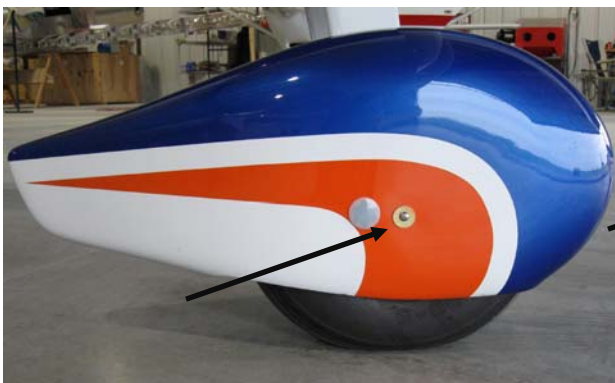
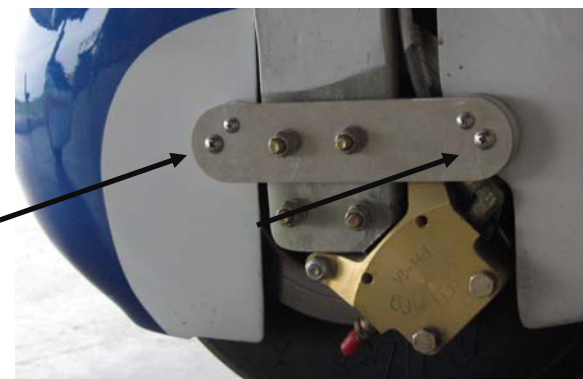
Figure 1: Wheel pant mounting screw locations

- d. Remove main wheel pant, if installed
 - i. Remove one outboard and two inboard wheel pant mounting screws as shown in Figure 1. Arrows indicate screws to remove.
 - ii. Lift pant carefully from wheel assembly.
- e. Remove original wheel pant bracket
 - i. Cut safety wire from bolts.
 - ii. Remove the two wheel pant bracket bolts.
 - iii. Remove bracket and discard.
- f. Install new wheel pant bracket
 - i. Install new bracket as shown using AN3H-5A bolts provided in kit.
 - ii. Install safety wire through both bolts as shown in Figure 2. Standard safety wiring practices apply.
- g. Reinstall wheel pant
 - i. Reverse the steps in Paragraph "d" to reinstall the wheel pant.
- h. Repeat procedure for other main wheel pant.

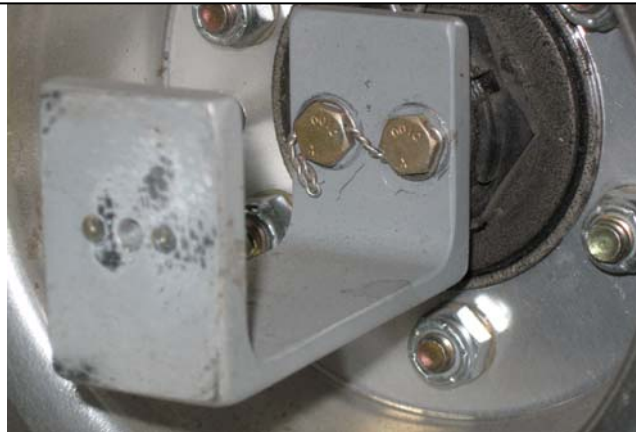
Figure 2: Replacement wheel pant bracket, bolts and safety wire

1. Inspection and Reinstallation
 - a. Level of expertise required: A&P, LSA Repairman / Maintenance, or service center authorized by Jabiru USA Sport Aircraft, LLC
 - b. Tools Required
 - i. Phillips head screwdriver
 - ii. 3/8" socket with extension as required
 - iii. Wire cutter
 - iv. Safety wire pliers
 - c. Materials and Parts Required
 - i. Two replacement outer wheel pant brackets
 - ii. Four AN3H-5A bolts
 - iii. Safety wire
